North Tahoe and Meeks Bay Fire Protection Districts

Alarming Increase in Gas Leaks, Carbon Monoxide-Related Emergencies

Tahoe City, Calif. Mar. 7, 2023 –North Tahoe Fire reports an alarming increase in gas leaks, Carbon Monoxide (CO) related emergencies and other hazard-related emergencies resulting from the repeated storms and heavy snow. Since January 1, 2023, hazard calls have accounted for nearly 20% of non-EMS incidents. Firefighters are on a mission to empower the public with information on ways to prevent snow-related emergencies by properly maintaining mountain homes.

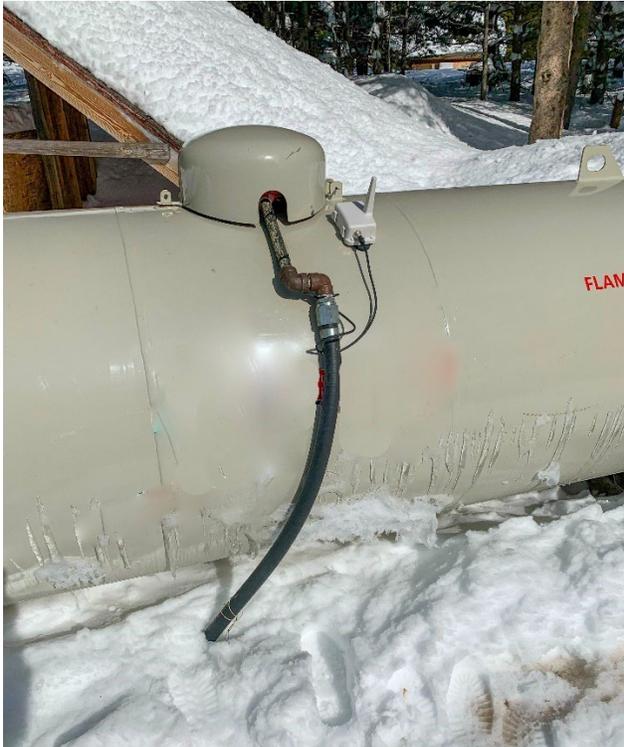
An image of a properly maintained propane tank, showing the above ground plumbing that is vulnerable to the forces of snow loading and torsional stress. Some plumbing is not flexible and more prone to failure.

Propane tanks/cylinders, gas lines, and regulators and appliance vents need to be continuously maintained throughout the winter by keeping them cleared of snow and ice buildup. The district recommends the following:

- Take caution when clearing snow from roofs and protect propane tanks or cylinders, propane lines, regulators, and vents from falling snow.
- When plowing, snow blowing or shoveling, do not push or pile snow around a tank, meter, regulator, or piping.

- Use caution when removing snow from the tanks and cylinders, gas piping and regulators; don't use sharp tools or force. Carefully clear heavy snow until the tank and equipment are visible, complete final clearing with soft tools such as brooms or brushes to prevent damage to equipment and components.
- Tanks should not be allowed to run dry; doing so may require an inspection of all gas appliances before the tank can be refilled. Be sure to place refill orders before the tank reaches 30-40 percent and keep tanks clear of snow with a path accessible to gas suppliers.
- Propane smells like rotten eggs, and propane leaking into snow may release more of a musty odor.
- Anytime there is an odor of propane or natural gas, call 911 immediately.
- Watch this [Propane Snow Safety PSA](#) (2019), courtesy of Placer County Sheriff and North Tahoe Fire.

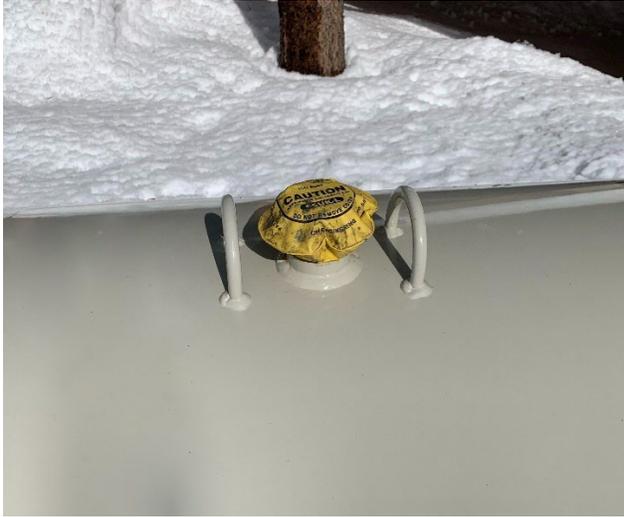
An image of a properly maintained bypass vent on a gas tank, which needs to be kept free of ice.

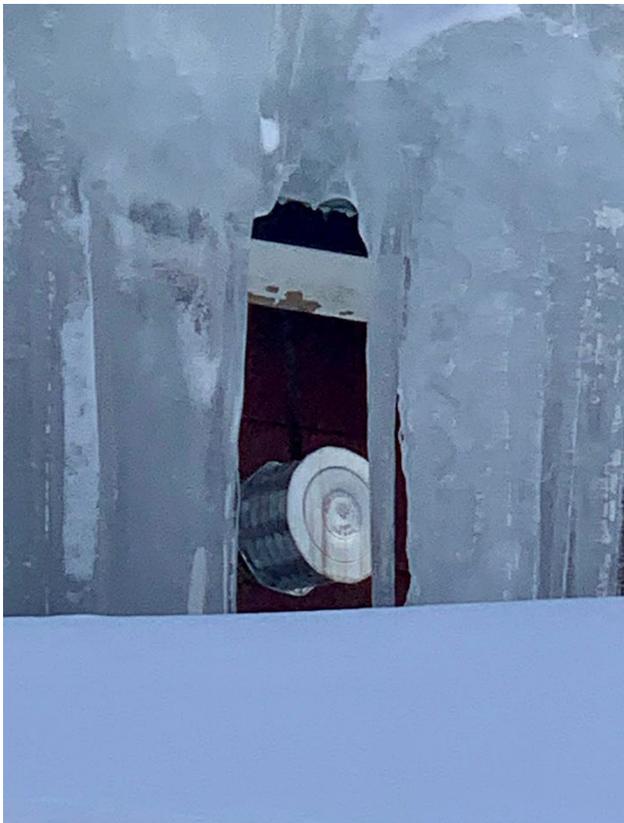
An image of combustion ventilation that is soon to be obstructed by snow. If left unattended, the obstruction could result in CO poisoning of the occupants.

North Tahoe Firefighters are responding to a significant increase in CO emergencies throughout the region, many of which result in positive CO readings upon arrival, with occupants/patients showing symptoms of varied severity. Many of these incidents are the result of heavy snow build-up on combustion-appliance venting, buried foundation vents, and improper or snow-obstructed home generator ventilation systems. Gas leaks are also on the rise due to deeply buried propane tanks, above ground propane plumbing, and buried natural gas meters impacted by the snow. The repetitive freeze-and-thaw cycles following winter storms combined with the weight of the snowpack places glacial-like torsional stress on tanks and propane plumbing systems, causing dangerous leaks.

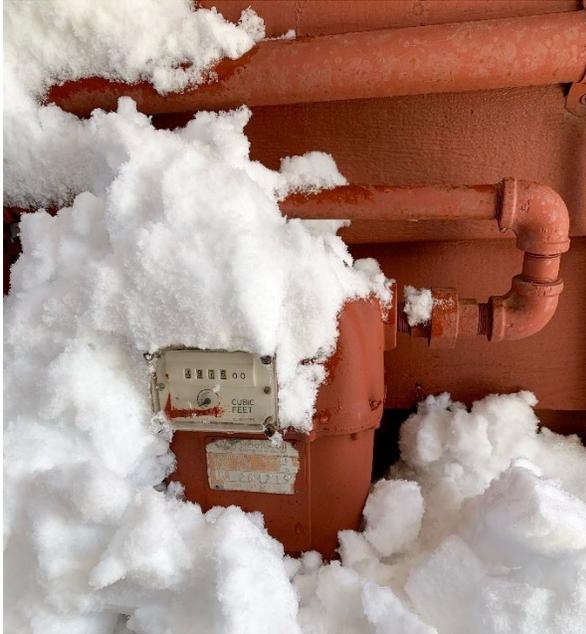
An image of a gas meter being cleared of snow to prevent a gas leak.

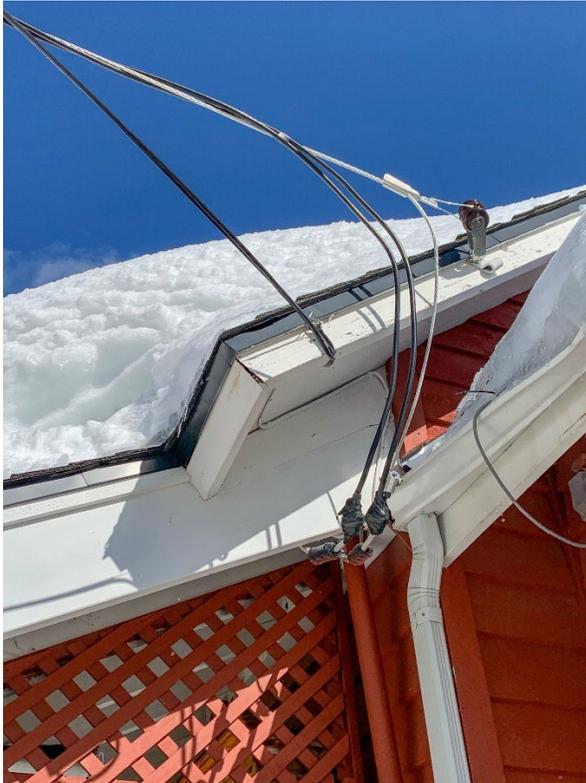
An image of 240V power service drops that may be covered in snow by roof cornices. If contact is made by an aluminum shovel or ladder when the snow is being cleared, the results could be fatal.

North Tahoe Fire urges residents to use caution while clearing snow from rooftops. “Be aware to stay well clear of the 240V power service drops that may be covered in snow by roof cornices,” said North Tahoe Fire Chief Steve Leighton. “An aluminum shovel or ladder that comes into contact with a power service drop can easily electrocute and kill a person.”
